## MARINE INVESTIGATION REPORT

M00L0114

### GROUNDING

**BULK CARRIER *FOSSNES***  
**OFF CAP MARTIN, ST. LAWRENCE RIVER**  
**18 OCTOBER 2000**

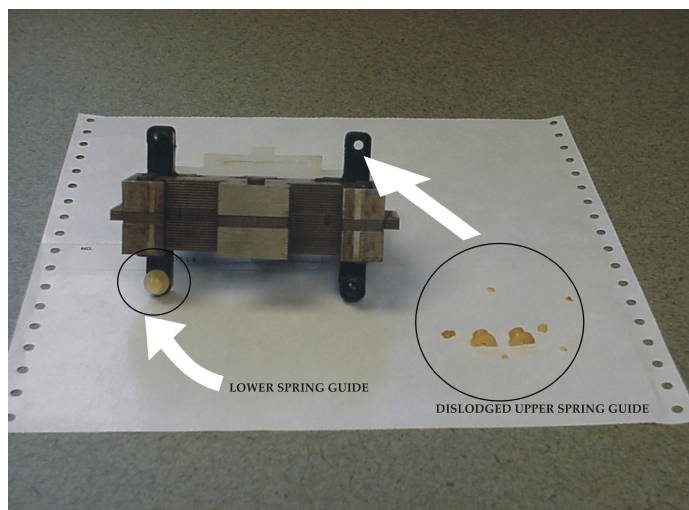
**Photo 1.** Moveable contact of Elester SLA 85 contactor.

After the grounding, it was observed that the contact surfaces of all phases were damaged by arcing burns, but damage was not uniform. Also, the moveable contact slid with difficulty over the fixed contact, preventing a positive contact.

Pieces of yellowish polymer from one of the spring guides were found scattered around the inside of the contactor casing, and one of the guides was dislodged (Photo 1). Polymer can deteriorate after prolonged exposure to chemicals, heat, cold, stress, sunlight, oxygen, moisture, or pollutants in the atmosphere. Any of these factors, either individually or collectively, will alter the chemical composition of the material. Symptoms such as surface fragility, yellowing, cracking, or loss of elasticity and resilience are all signs of chemical deterioration.

An inspection of the No. 2 power unit contactor revealed that one of the spring guides was also broken and showed signs of chemical deterioration. The working life of the two contactors was approximately the same.

The contactor malfunctioned because small pieces of polymer affected the mechanical movement of the contactor. The deterioration of the polymer used to manufacture the spring guide shows the importance of carefully monitoring the condition of parts and the environment in which the parts are intended to be used.<sup>5</sup> The degradation of this polymer contributed to the reduction of the theoretical service life of the contactor and created an overcurrent in the supply circuit. Since the three contactors examined had the same defect, the choice of contactors used on board can be questioned.

The TSB sent Marine Safety Information Letter (MSI) 01/01, concerning the contactor defect, to the owner, with copies to the manufacturer, the Administration of the Registry, the shipyard, and the International Association of Classification Societies. The manufacturer, Hydroster, had decided to use other types of contactors as a result of testing new products in 1997.

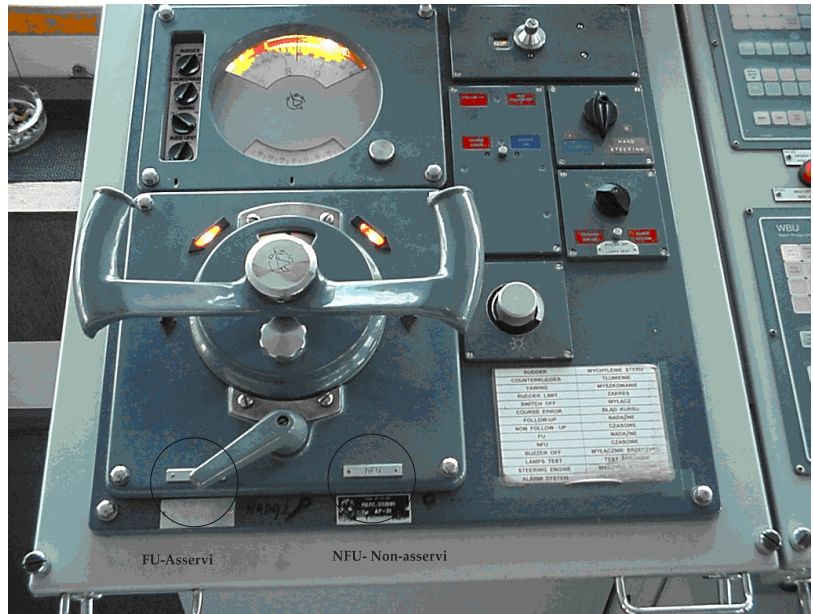
**Photo 2.** Arrangement of steering control console.

The rudder is activated by a steering wheel on the steering control stand (Photo 2). Below the steering wheel, there is a selector switch used for selecting FU or NFU control mode. The electrical circuit for the FU control mode was energized from the No. 1 starter panel power unit; the NFU control mode was from the No. 2 .

The OOW and the helmsman reported that they tried NFU control mode immediately after the breakdown. However, since they observed no rudder movement from the rudder indicator, they again selected FU control mode.

The NFU control mode was tried in the moments following the rudder failure, but this mode transfer did not produce the desired effect. The investigation showed that the No. 2 power unit was operating during the occurrence. Moreover, the No. 2 power unit did not trigger any alarms or trip the No. 2 circuit breaker. When the chief engineer and the electrician arrived, the No. 2 power unit was operating normally. Hence, NFU control mode should have been operationally ready throughout the occurrence.

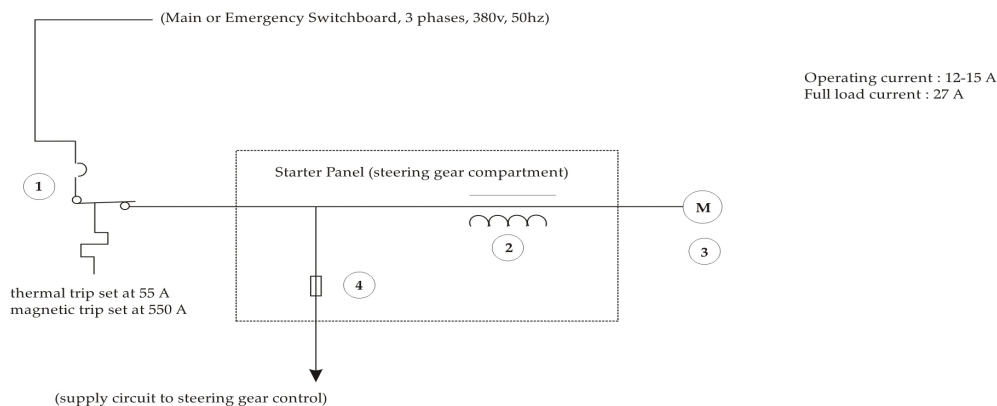
**Figure 1.** Electrical arrangement of steering gear power unit and control circuits.

When the breaker trips, it will cut power to all circuits connected to it because the steering gear control circuit is connected to the main breaker output of the power unit's power circuit.

The supply circuit of the ship's steering gear control was in compliance with SOLAS requirements. However, although it was in compliance, the point from which power is taken and the location where the overload device is installed could allow an unanticipated breakdown of the control system in FU mode and NFU mode. A test determined that the sudden tripping of the main breaker results in the de-energizing of the supply line to the No. 1 power unit and, consequently, a failure of the FU control mode (Figure 1).

To protect the supply line, the main breaker of power unit No. 1 has two protection devices: one for short circuits and one for overcurrents. These two types of protection are acceptable pursuant to the SOLAS Convention. After the grounding, the test with a megohmmeter on the electrical components of power unit No. 1 revealed no evidence that a short circuit had occurred. All indicates that the malfunction of the closure mechanism of the power unit motor contactor, combined with the high starting current following several starts, contributed to an overcurrent exceeding the setting for long-delay protection. Hence, this excessive overcurrent tripped the main breaker.

1. The tripping of the main circuit breaker cut power to the supply line of the No. 1 power unit and, consequently, resulted in the failure of the FU control mode.
2. At the time of the failure, the rudder was turned to starboard. The crew was unable to restore steering gear control.

1. The point from which power is supplied and the point where the overload protection device is installed can allow unexpected failure of the control system.

The TSB sent MSI 08/01, concerning the inadequacy of SOLAS regulations on steering gear electrical systems, to Transport Canada. If Transport Canada deems necessary, a submission can be made to the International Maritime Organization.

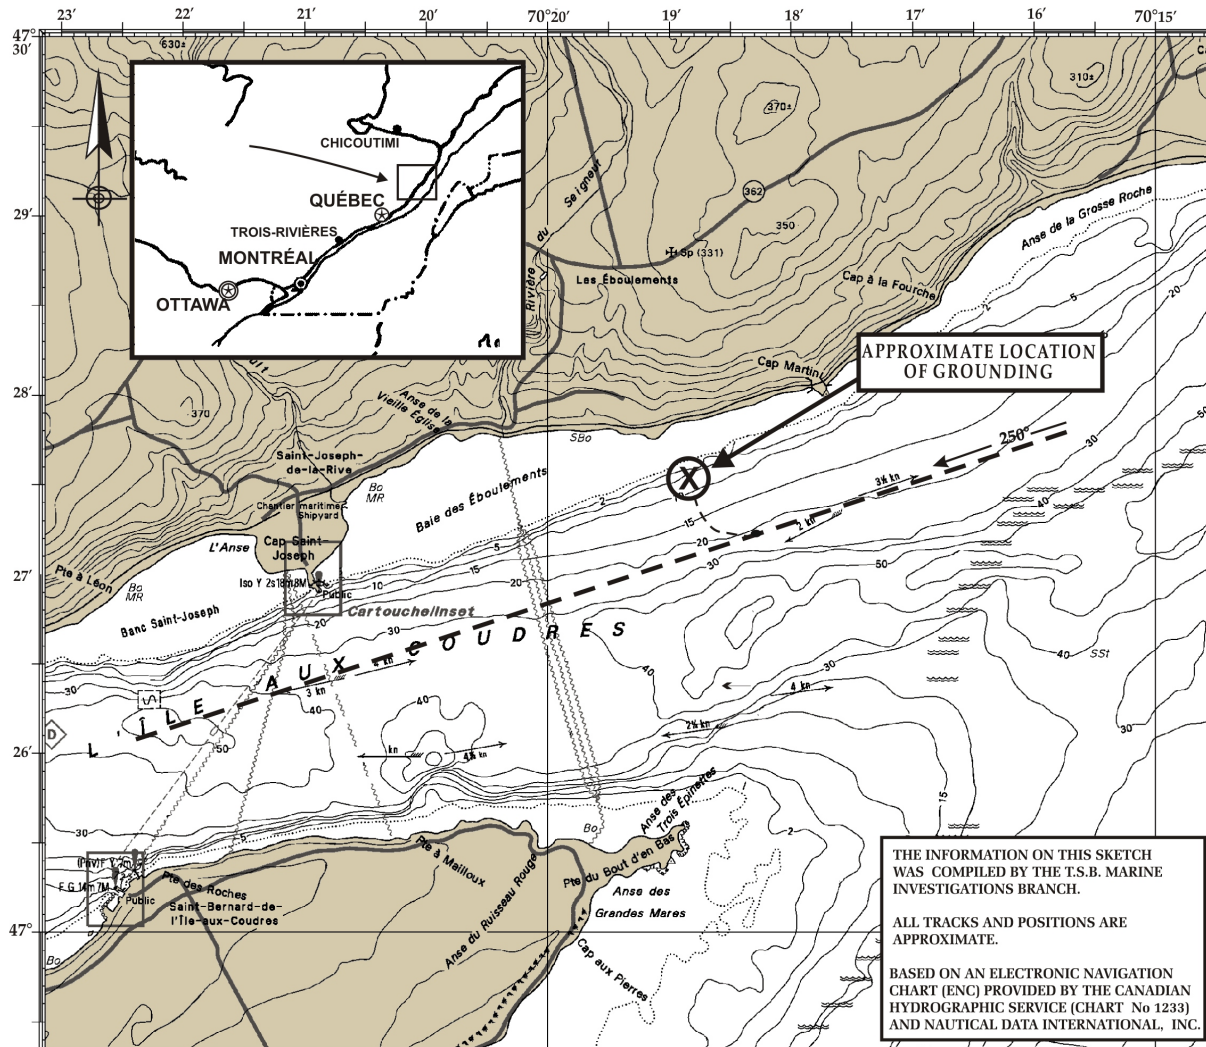
# Appendix A—Sketch of the Occurrence Area

Although both anchors were let go, the vessel continued its swing to starboard. At 1201, the vessel grounded in position latitude 47°27'48" North and longitude 070°17'54" West, about two cables southwest of Cap Martin.
